Eroded shoreline at Ile Diamant North West Peros Banhos

Sea level change and shore erosion

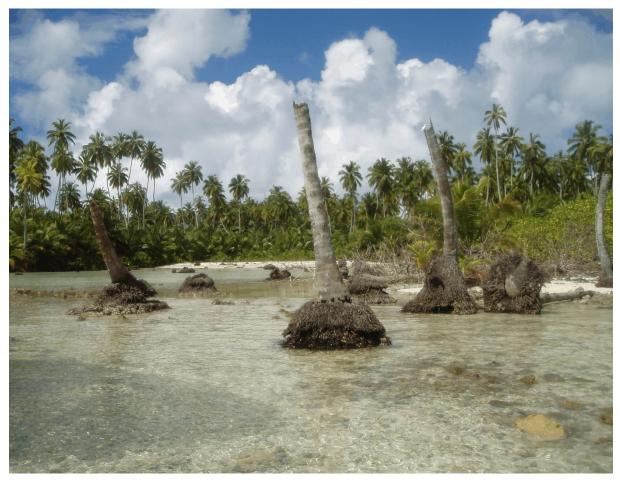
Rising water erodes shorelines. This shows up first when the sea strips away thick layers of sand and soil at the water's edge, and this progresses landwards, flooding depressions. Underlying the sand is older and more solid reef rock. This photograph from Ile Diamant, North West Peros Banhos is typical of an increasing number of sites. These palms have been dead for years, and clearly grew for perhaps 40 years before their substrate was stripped away. This site now shows a different, and probably changing, equilibrium between land and sea to the one which existed when these palms grew. This is partly a natural, progressive and seasonal phenomenon, but setbacks to coral growth and rising sea levels accelerate the erosion.
